# REASSESSMENT OF THE FINANCIAL PROVISION FOR MTHATHA QUARRY, MAGISTERIAL DISTRICT OF MTHATHA, EASTERN CAPE PROVINCE

MINING RIGHT: 120/2009  
FILE REF NO: EC30/5/1/2/2/0135MR

**MAY 2025**

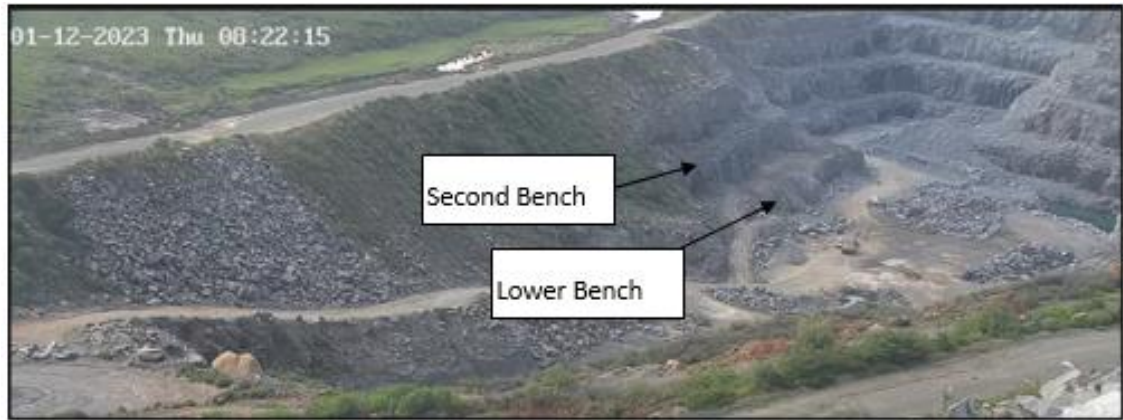
During 2024, the Quarry continued with the rehabilitation of the area identified by the rock engineer (Rock SSS) in 2023 and shown below.

*Figure 1: Image showing the special area to be rehabilitated (image obtained from the Rock SSS Report, 2023).*

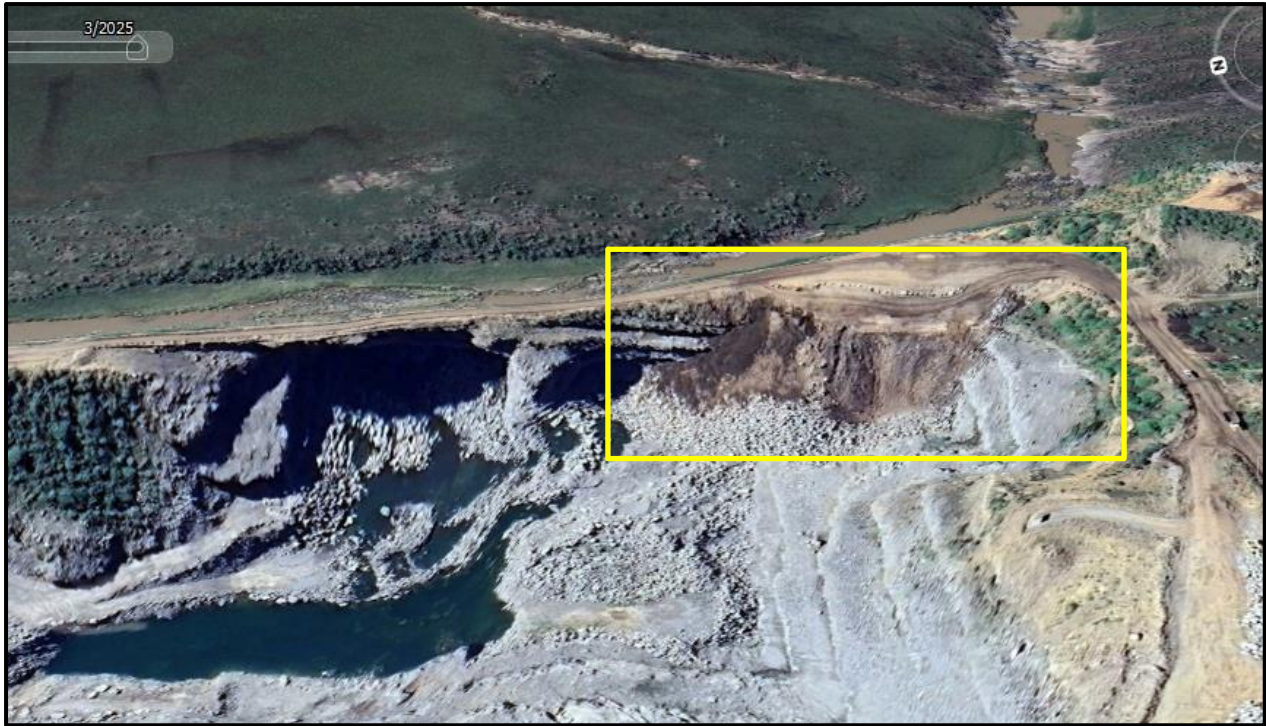
Overburden and topsoil removed from the south-western corner of the quarry pit was used to improve the slopes of the benches at the earmarked rehabilitation area ( $\pm 0.5$  ha) as indicated below.

Figure 2: Satellite view of the south-eastern corner of the quarry pit where the eastern benches ( $\pm 0.5$  ha) are being rehabilitated (yellow polygon). (Image obtained from Google Earth).

The MR Holder continues with the rehabilitation of the eastern side of the quarry pit ( $\pm 0.5$  ha area) that will also improve the integrity of the nearby haul road passing the area. Rehabilitation of this area will continue during the forthcoming 12-month period.

As mentioned earlier, the rehabilitation of the benches along the eastern side of the quarry pit is in progress and will continue for the forthcoming 12 months. The area under rehabilitation is  $\pm 0.5$  ha in size.

Unwanted overburden, large rocks and topsoil were used in the sloping of the said benches along the eastern side of the quarry pit. It is important that the topsoil is only placed after final rehabilitation as the top layer. No overburden and topsoil may be mixed.

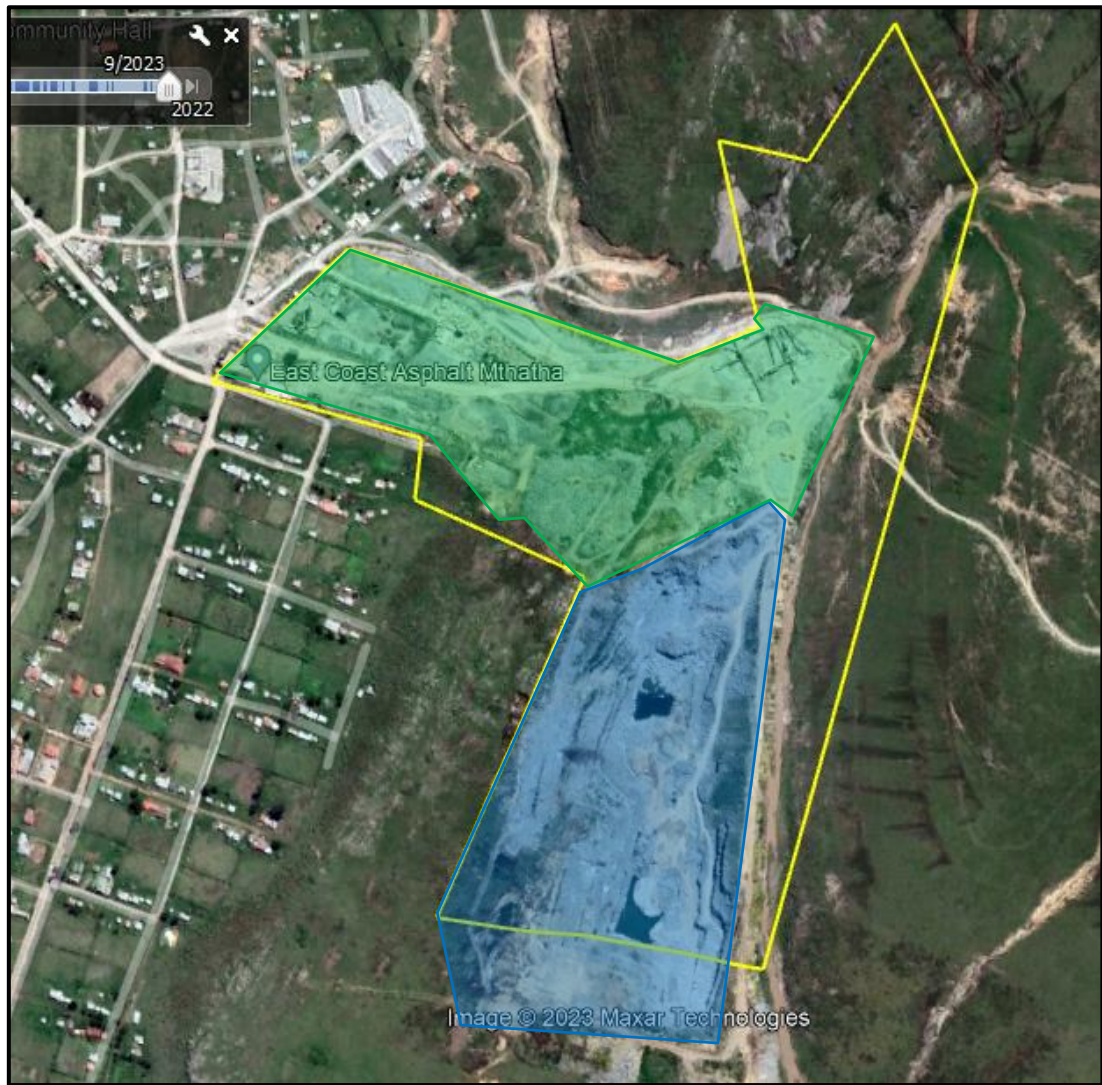
Upon rehabilitation the mining area will either revert to agricultural use and be suitable for grazing purposes or be incorporated into the nearby residential area. The quarry pit will be left as a landscape feature.

Figure 4: Satellite image of the mining area to be rehabilitated upon closure. The processing and mining related areas (green) will revert to agricultural/residential use upon rehabilitation, and the quarry pit (blue) will be rendered safe and left as a landscape feature.
